Belzona Prevents Costly Leakage

Cement Plant,
Bulgaria

Ball Mill used to grind limestone for cement production.

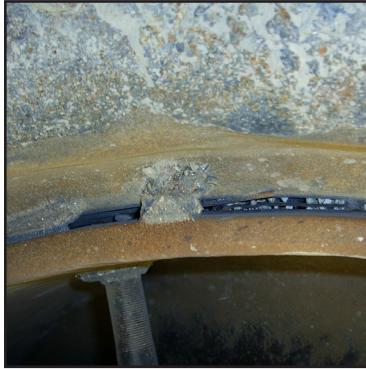
View of the gap between the tubular screw conveyor and the housing

The ingress of limestone particles into the 10-20mm gap between the tubular screw conveyor and its housing leads to wear and leakage of milling media outside the mill.

The Belzona was chosen in order to prolong the life of tubular screw conveyor. The customer had used different epoxy-based products to solve the problem but with limited success. Welding was not considered due to high cost and stress buildup. The Belzona solution proved to be much easier and faster to apply saving the plant more than 5000 euros in replacement and maintenance costs.

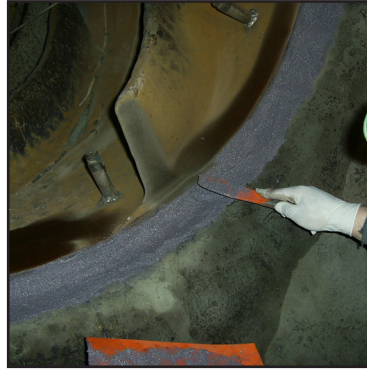
Belzona[®] 1812 being applied

Application was carried out in accordance with modified versions of Belzona Know How Leaflet GSS-9 and VPF-2.

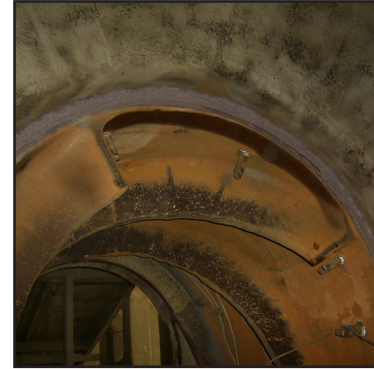
Completed application
