## Belzona Repairs to Cement Fan Shaft

Cement fan shaft.

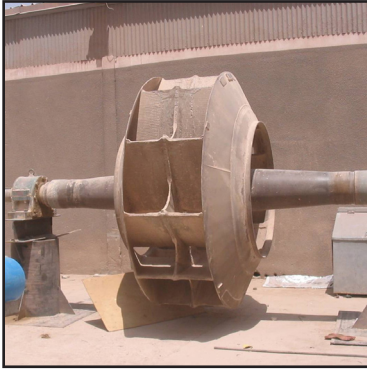
General view of the fan shaft

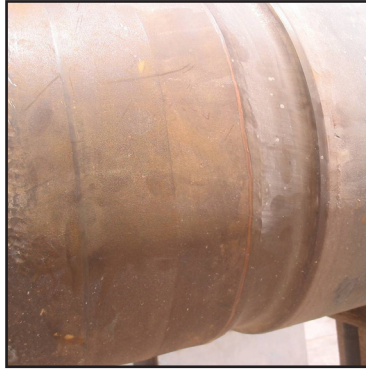
The worn out shaft

Deeply worn shaft due to abrasion from cement - leading to potential bearing failure.

The dimension of the shaft was restored and the repair was completed without machining. A conventional repair method to repair this shaft was not a favorable option due to the high costs of welding and machining in addition to the large fan that cannot be separated from the shaft.

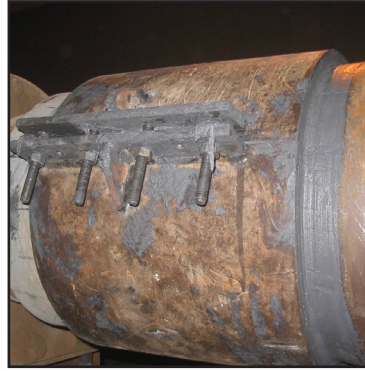
Form was applied

Application was carried out in accordance with Belzona® Know-How System Leaflet MPT-2.
