Belzona Extends Chiller Life

International Airport,
Stockholm, Sweden

3 chiller units for air conditioning of terminal buildings.

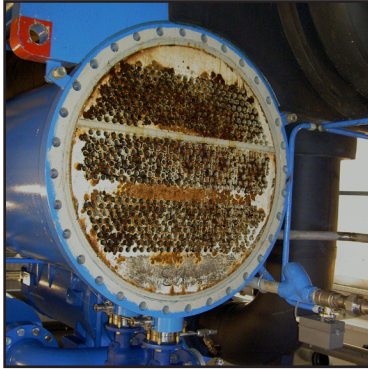
General view

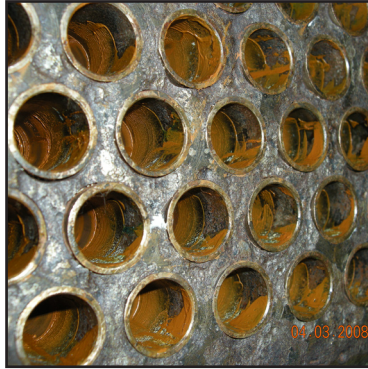
Close up of erosion on tubesheet

Corrosion on tubesheets (4) from one of the chillers was noticed in 2005. Cooling water comes from a local lake which together with galvanic effects was the cause of the corrosion.

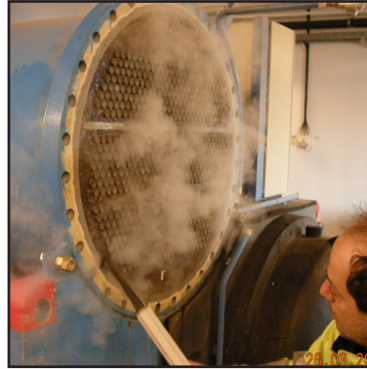
Steam cleaning

Application was carried out in accordance with Belzona System Leaflet HEX-1. Surface preparation included steam cleaning to remove salt contamination.
