## High Speed Patrol Boat Stabilized with Belzona

Stabilizer from a MK-5 High Speed Patrol Boat

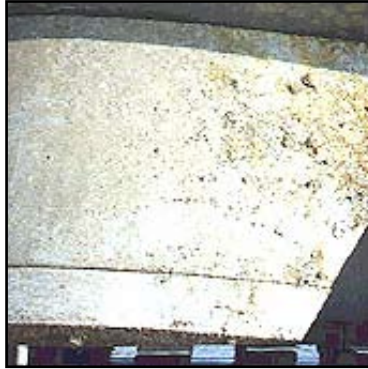
Cavitation damage to stabilizer trailing edge.

Much like a rudder, cavitation damage will manifest itself on the areas of greatest pressure differential. In this case, entrained solids and cavitation caused metal damage to the trailing edge of the patrol boat's two stabilizers.

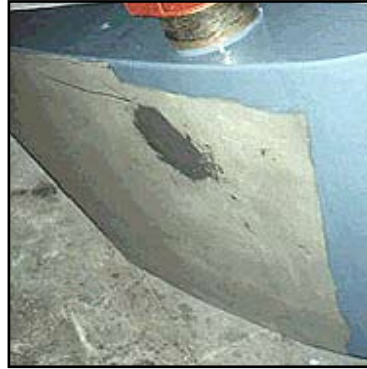
Rebuilding cavitation damage.

The application was carried out in accordance with Belzona Know-How System Leaflets SOS- 1 and -2.

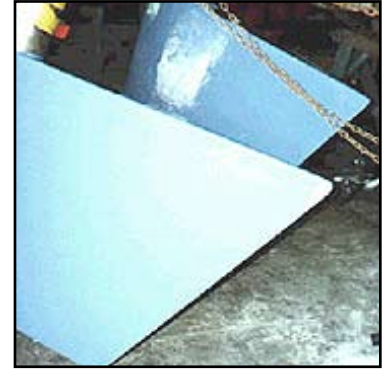
Both stabilizers completely rebuilt and coated.

Belzona® 1311  
(Ceramic R-Metal)  
Belzona® 1341  
(Supermetalgilde)
