## Belzona Provides Sea Water Filter Protection

Sea Water Filter System on offshore oil production platform.

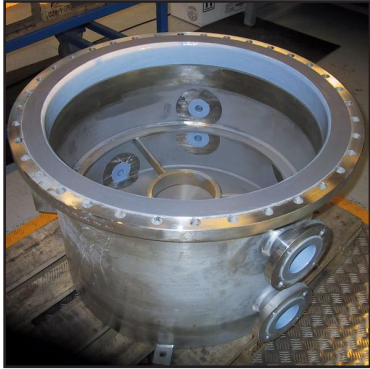
Main body of filter

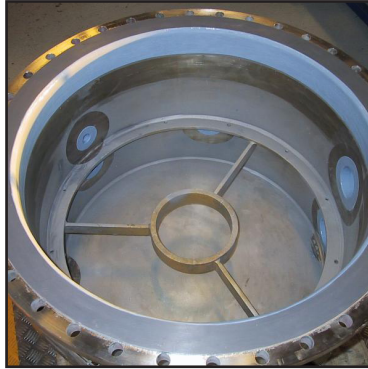
Vertical view showing protected flange faces

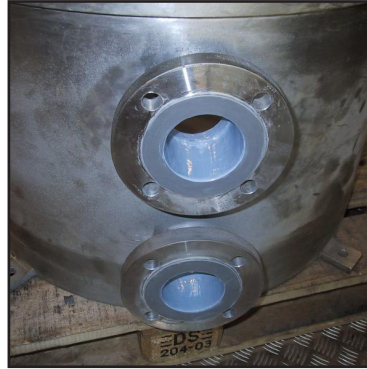
Exit nozzle coating

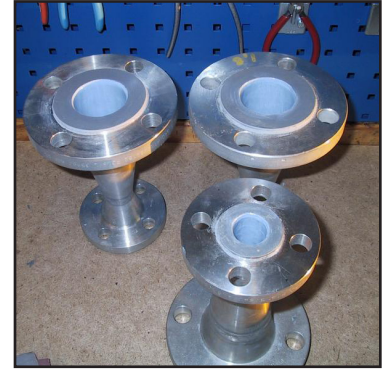
Individual small bore nozzle coating
