Acid Containment Floor Re-Hab with Belzona

Water Treatment Plant,
Oklahoma, USA

Floor and sump access-way in water treatment plant.

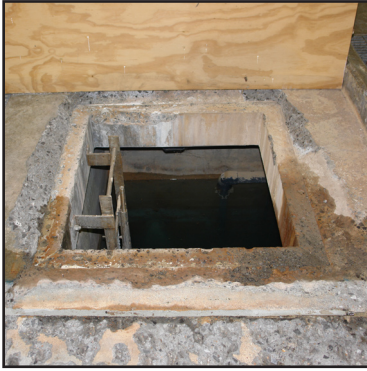
Floor prepared for resurfacing

Application was carried out in accordance with Belzona Know-How System Leaflets FPA-1 & 3. Bulkfill was used to rebuild the sump access and spalled areas. The entire area was then given two coats of Immersion Grade with Surefoot Aggregate applied to achieve safe footing.

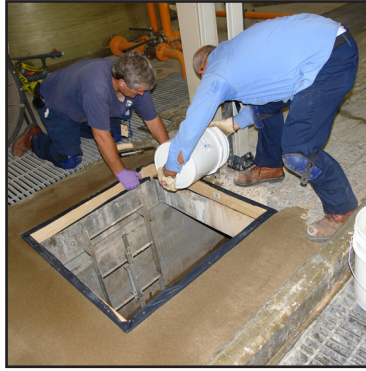
Reshaping the access opening

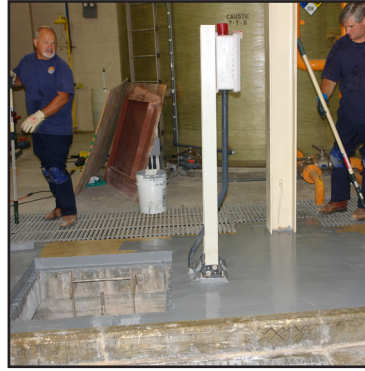
Belzona® 5811 Grey coat over Beige with Surefoot added

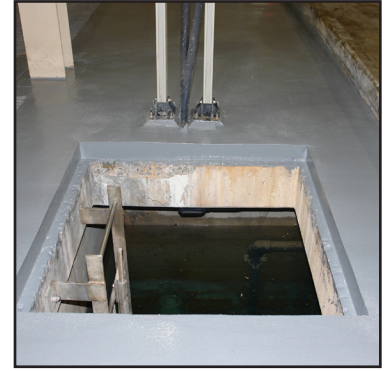
Rebuilt, protected, a first class job
