## Belzona Protects Cement Packing Machine Steel Plates

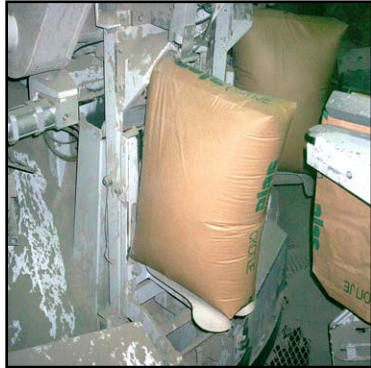
*Cement packing machine.*

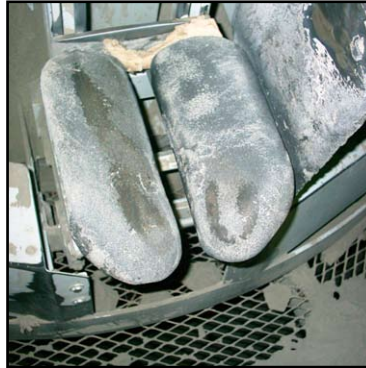
*Condition of the coated steel plate and steel seat after one year in service.*

Initially done as an experiment, the cheapest base metal was chosen and coated with Belzona. One year later the plates were inspected and were found have suffered from no wear at all. Belzona® 1812 would be expected to give similar results.

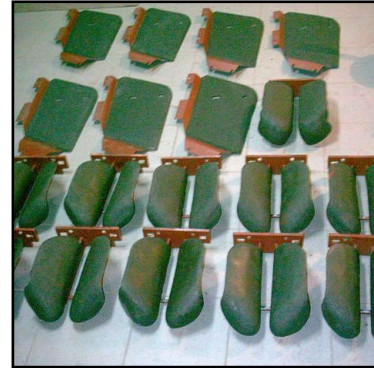
*Repaired seats and sheets.*

Deterioration of the steel plates and steel seats due to wear from the cement bags.

Belzona® 4811  
(Magma AR Screed)

Application was carried out in accordance with Belzona® Know-How System Leaflet SHM-13.
